Manhole Inspection Summary

Manhole # S27C__048MH

Insp Date: **11/29/07 1:38 PM**

Location Address: **323 FREMONT AVE**

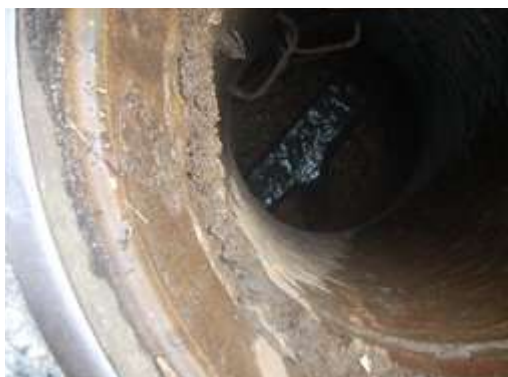
Defect 1

Offset: **1** (in.)

FRAME OFFSET

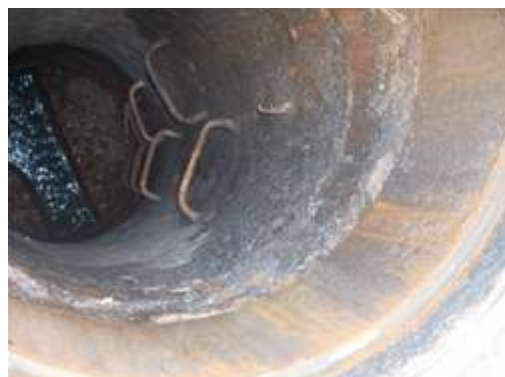
Defect 5

Count: **6** Missing: **1** ☒ **Corroded**

MISSING AND CORRODED STEPS

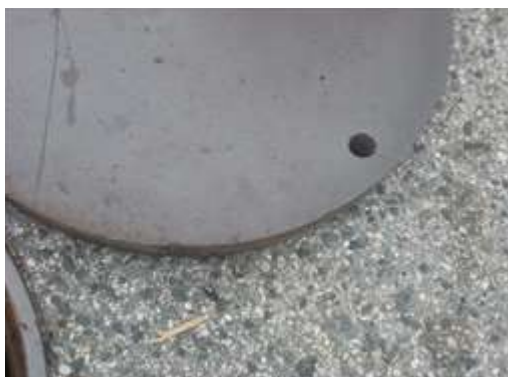
Defect 3

Condition: **Worn**

WORN COVER

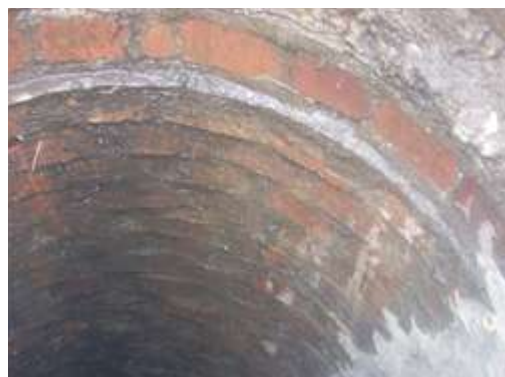
Defect 4

Infiltration: ☐ None ☐ Joint ☐ Cracks ☐ Mortar ☐ Roots ☒ **Wall**

CHIMNEY INFILTRATION

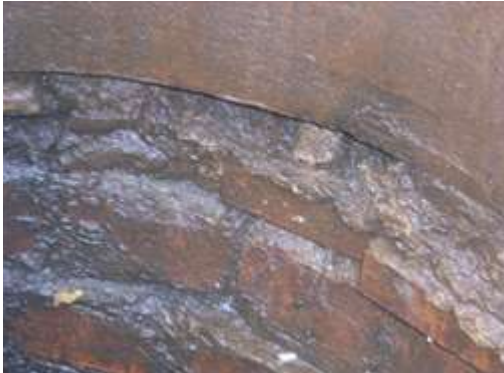
Defect 2

Condition: ☐ Sound ☐ Cracked ☐ Root Intrusion ☐ Loose Brick ☒ **Deteriorated**

DETERIORATION OF CHIMNEY AND
INFILTRATION

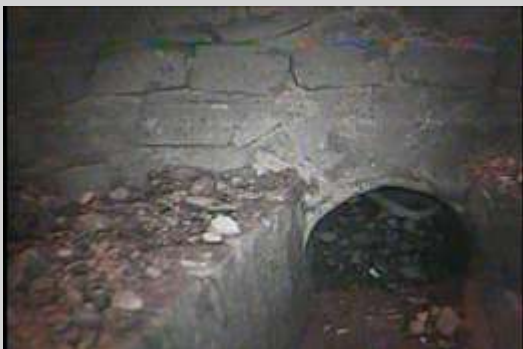
4 O'Clock Inflow

Pipe Height: **7.2** (in.) Rod and Bar (Angled)
Pipe Material: **Clay** ☐ Pipe Lined
Invert Depth: **14.20** (ft.) Flow Characteristics: **None**
Deposits: ☐ None ☐ Mud ☐ Sludge ☒ **Debris** ☐ Grease
Silt Depth: **2** (in.) Deposits Extent: **Medium**
Infiltration: **None** Pipe Seal Cond: **Sound**
